FLORENCE COPPER INC.

February 17, 2021

Subject: Underground Injection Control (UIC) Permit Number R9UIC-AZ3FY11-1

Notification of AL and AQL Exceedances at supplemental monitoring well M59-O

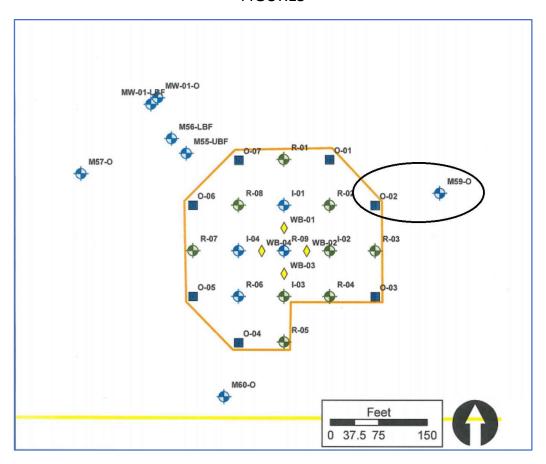
Figure 1. PTF Wellfield

As stated in the 5-day report, supplemental monitoring well M59-O is located on the east side of the PTF well field (see Figure 1). Analytical results for water quality samples taken from this well over the past year and a half have shown alert level exceedances for a number of analytes. Corrective actions that Florence Copper institutes when there is an alert level exceedance include sending a camera down the well to create a video log of the inside of the well. If the video log shows that precipitates have built up in the well, the well is redeveloped. The well may also be pumped continuously to try to clear out the precipitates. These corrective actions have been successful in lowering parameter concentrations below AL/AQL thresholds.

A review of data from wells in this area of the wellfield suggest that pumping M59-O in November and December may have drawn water from nearby observation well O-02 towards M59-O. Observation well O-02 is approximately 100 feet west of supplemental monitoring well M59-O (Figure 1). Water level data show that when M59-O was pumped in December, groundwater elevations at O-02 decreased by seven feet, and recovered quickly when pumping stopped (see Figure 4).

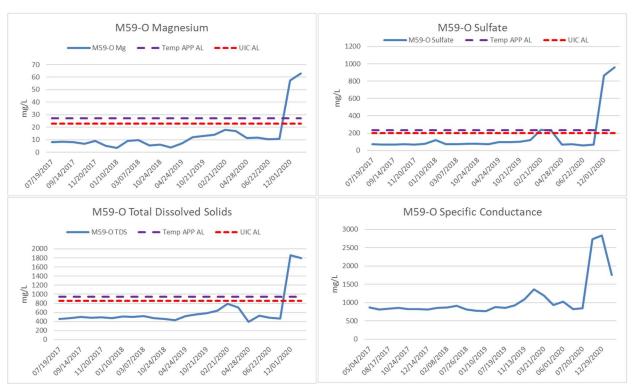
Figure 2. Indicator parameters and conductivity concentrations vs time at M59-O

The cause of the exceedances at M59-O may be related to previous pumping activity conducted at this well. Florence Copper installed a submersible pump in M59-O on November 18, 2020 which was run to clean out any precipitates that may have accumulated on the well screen, and to collect the initial and verification groundwater samples for the quarter. Though pH levels remained above 7.0, pumping of M59-O increased the conductivity and the concentrations of indicator parameters and radio chemistries (see Figures 2 and 3).

On February 16, 2021, a week after pumping began at observation well O-02, a conductivity measurement was taken at M59-O, and the results showed that the conductivity had decreased by approximately 1,000 μ S/cm. This data point is included in the conductivity concentration versus time
